**EG&G INVESTIGATION
INTO THE
CHEMICAL AGENT DISCHARGE
AT THE
TOOELE CHEMICAL AGENT DISPOSAL FACILITY**

May 15-26, 2000

John M. Kersh, Chairman
EG&G Investigation Team

Date: June 9, 2000

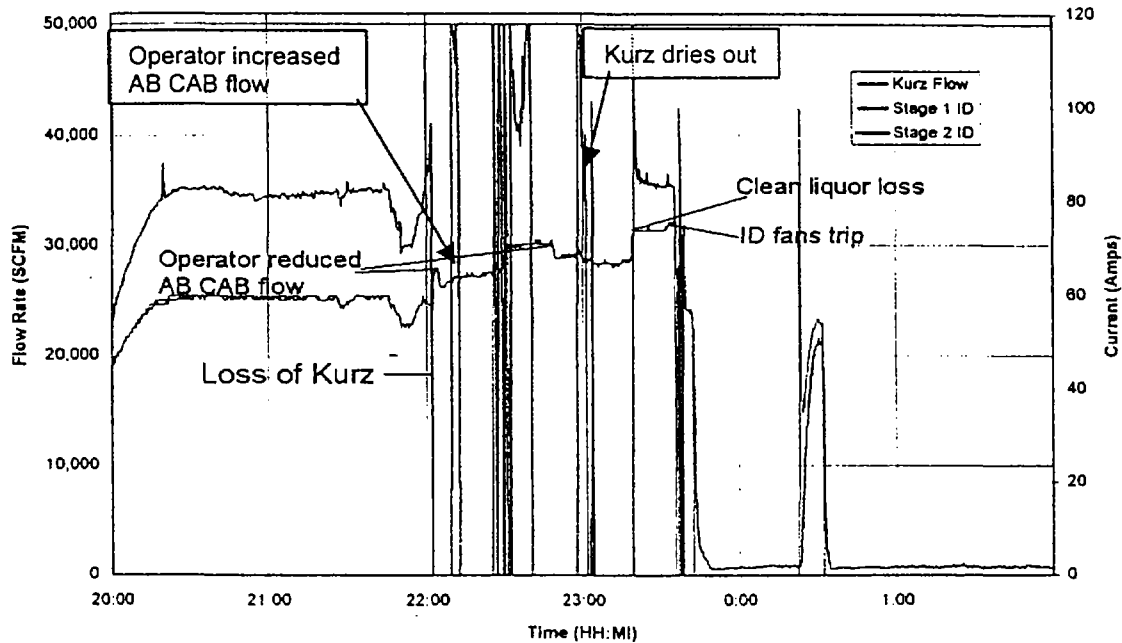
FIGURE 1.

- 22:02 While the furnace and related Pollution Abatement System (PAS) systems were still under extremely high vacuum and high flows, a vital (Kurz) flow metering instrument--near the scrubber/mist eliminator outlet-- failed due to high moisture carry over causing a shutdown of the "kiln" burner and two "Afterburner" burners— a condition referred to as lock-out. The failure of this vital instrument caused the loss of burner management permissives, thereby requiring a 14-minute purge necessary for burner relight. During this process, the Kurz flow malfunctioned intermittently prohibiting the completion of the purge and causing additional cooling to the furnace. The DFS operator continued attempting to restore normal flows and pressures while assisting trouble-shooting efforts including implementing the work order process and also working with maintenance personnel on this vital flow measurement instrument. See Appendix B, Figure 1 for flow history and analysis.

DFS System Flow Rates - May 8-9, 2000

Figure 1 depicts flow rate on May 8, 2000 starting at 2000 until 0200 the next morning. The ID fan current is also shown. The original intent of the memorandum OMM-005 was to establish a differential pressure between the ECR and the kiln to keep hot material from migrating into the ECR during DPE entry. To lower the pressure in the kiln, the operator increases flow through the system by opening the ID fan damper. He can do this by changing the kiln pressure controller setpoint, or by taking direct control of the ID damper. The amount of flow necessary to achieve the -1.5 in WC pressure in the kiln required almost double the flow of a normal operation, nearly 36,000 SCFM compared to about 18,000 SCFM earlier in the day. The increased flow had several consequences. Carryover from the scrubber to the demister increased leading to loss of liquor in the scrubber. In turn this led to a low sump alarm that prompted the operator to add process water as he had done before in other low sump situations. However, the high flow entrained additional process water and bathed the Kurz meter. It malfunctioned and the BMS secured fuel to the burners. High flow reduced residence time in the after burner below two seconds and also reduced pressure in the kiln. The loss of clean liquor at about 2320 had the effect of increasing ID fan current and drying out the Kurz meter. An interesting feature in figure 1 is that the ID fan current continued to increase while the Kurz meter was inoperative due most likely to the amount of moisture that was carried over to the fans. Also the effect of AB CAB operation on fan current during the failed purge attempt between 2229 and 2249 is clearly evident.

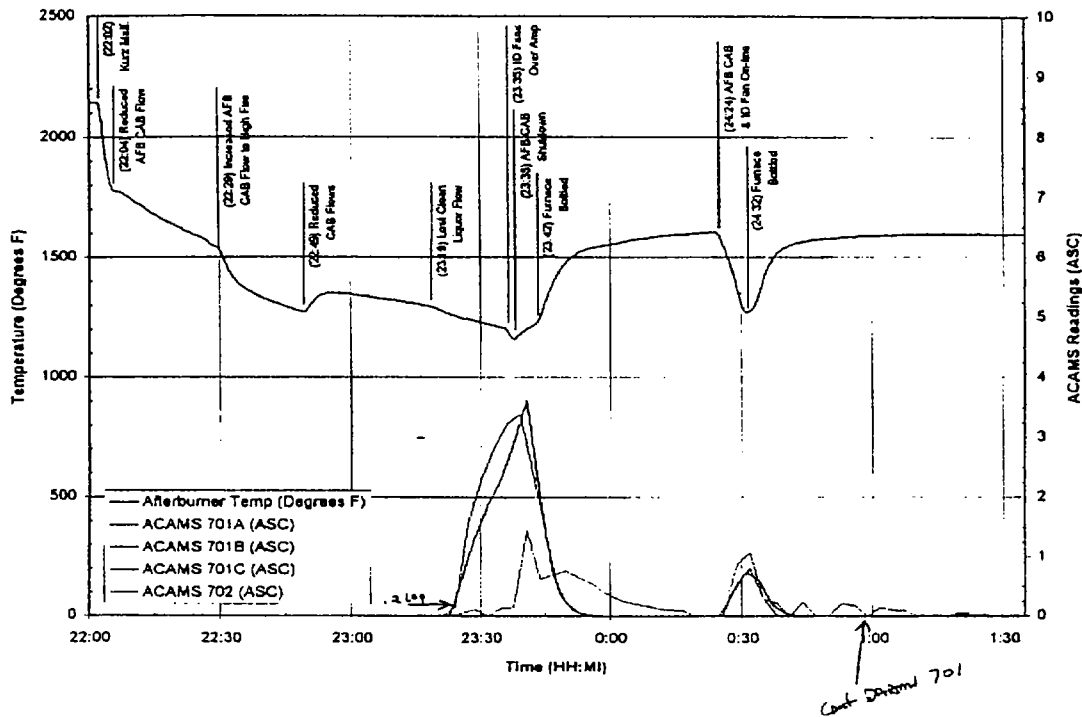
FIGURE 2.

- 22:34 The Afterburner's first reading below 1,400° F caused an interlock alarm preventing relight of the burner. At this point, The CRS could have directed the DFS operator to discontinue the purge to reduce cooling and bottled up by turning off the ID fans and combustion air blowers to allow the Afterburner temperature to rise because of heat capacity in the refractory brick. See Appendix D, Figure 2 for the after burner temperature history and analysis.

- 23:36 CABS in the Afterburner to "high fire" as an auto function on loss of ID fans. CAB blowers were manually shut down By DFS operator. CAB flows go to zero. Negative pressure values of -2" (-3.5") and -6" WC return to the kiln and Afterburner. Agent vapor is again drawn into the DFS from ECR B. Afterburner temperatures were at 1,205° F and 1,238° F. Operator puts Emergency Blower in manual and stops it. See Appendix B, Figure 2 for the after burner temperature history and analysis.

DFS Afterburner Temperature and Stack ACAMS Readings – May 8-9, 2000

Figure 2 depicts the after burner temperature as a function of time between 2200 and 0130. The stack and DFS ACAMS data are plotted against the same time period. Significant operator actions and events are identified at discrete times. The after burner temperature drops rapidly when burners are secured, then more slowly as AB CAB air is reduced. This marks the loss of the design engineered barrier to agent release, gas temperature above 2050 degrees Fahrenheit and residence at that temperature for at least two seconds. The failed restart effort is again obvious. When clean liquor is lost at about 2220, agent begins to exit the stack. The stack ACAMS sample the flue gases for three minutes then checks for agent. At about 2223, agent begins to register on the stack ACAMS and exceeds alarm levels after the next three minute read cycle. Levels climb until ID fans trip on overcurrent and the flow stops. The delay in the DFS ACAMS reading (702) was caused by caustic from carry over. The caustic was drawn into the ACAMS probe and neutralized agent in the air sample before it registered. As the agent flow continued, it finally overpowered the carry over caustic and began to register. The long tail on the plot for 702 was due to monitors challenging the ACAMS.

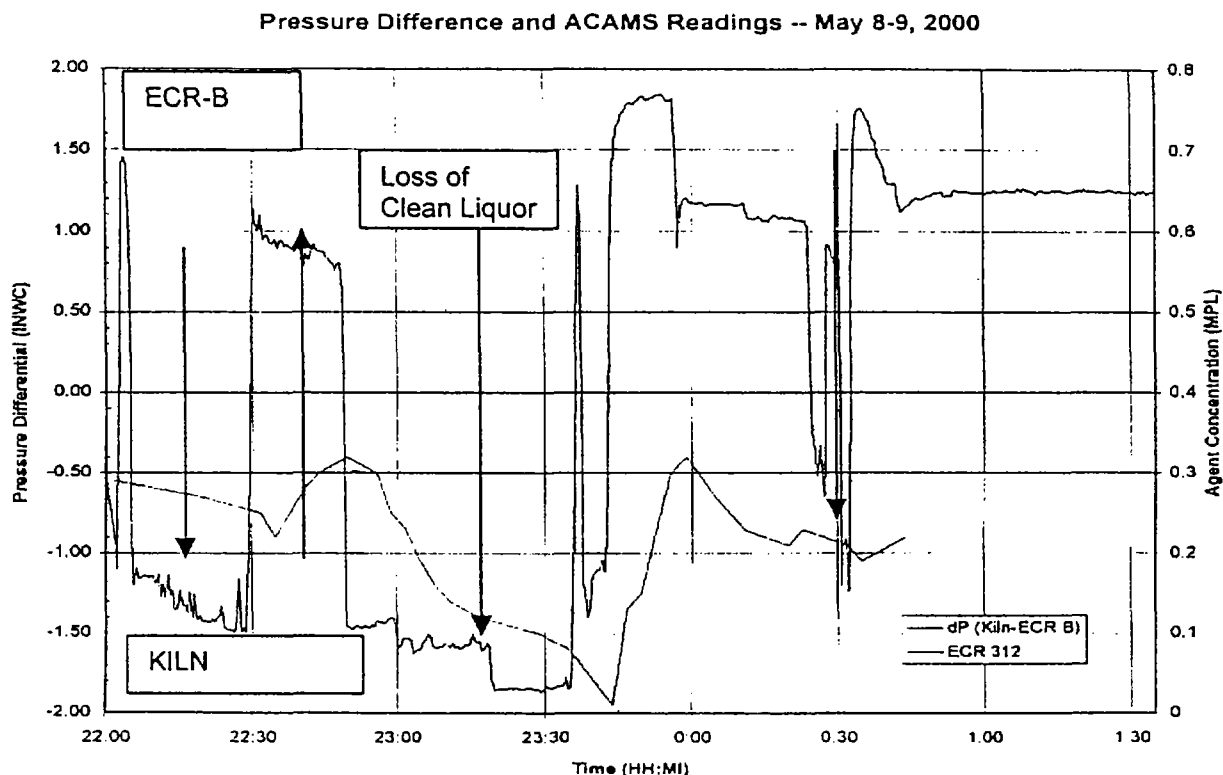
FIGURE 3.

Figure 3 plots the differential pressure between the kiln and the ECR-B for the same period as figure 2. The ECR ACAMS data is also depicted as well. When the differential pressure is negative, agent vapor flows from the ECR into the kiln around the gates and through the chute. When the pressure is positive, flue gases flow from the kiln toward the ECR up the chute. This differential appears to be very sensitive to AB CAB flow at this high flue gas flow rate. At 2230, the AB CAB flow is increased to purge for a relight attempt and the differential pressure shifts from -1.5 to +1.0, then returns to -1.5 when the AB CAB airflow is reduced at 2249. In this condition, agent vapor is drawn into the DFS from the ECR under very high flow conditions with no burners on line. Agent at some significant concentration gets through the kiln, after burner, quench tower, and is neutralized in the scrubber until clean liquor flow is secured by the operator. At that point, agent is drawn through the rest of the system and sent up the stack. Agent concentration in the ECR is significantly reduced when the differential pressure is negative consistent with removing agent from the room through the DFS chute. When the pressure is positive, agent is drawn through the ECR ventilation system past the ACAMS and the indicated concentration increases.
